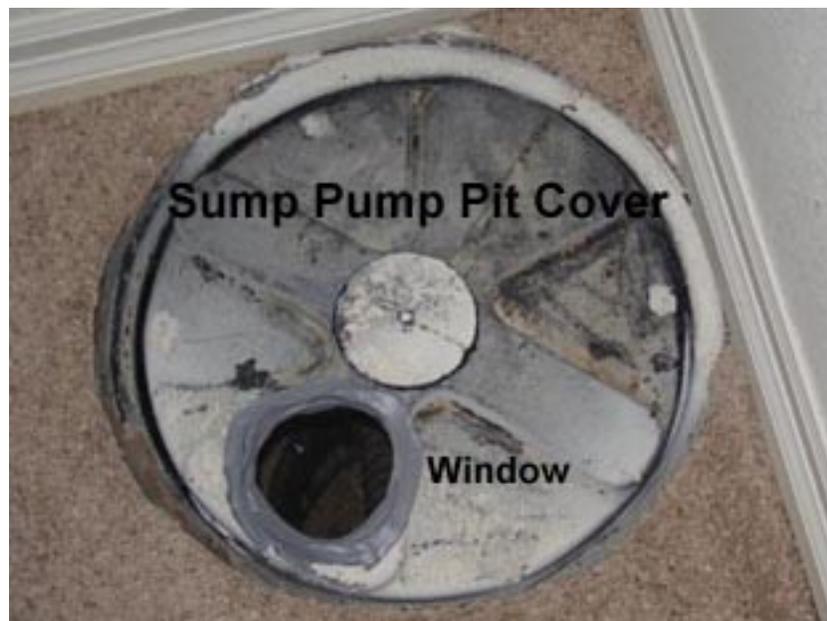
Sump Pump Pit:

We have never had any flooding. They glued a little window into the Sump Pump Pit Cover and then sealed the Cover in place. In a rainy period, we can shine a light into the little window and assure ourselves that there is no water accumulation. The continuous Radon venting helps prevent the water accumulation.

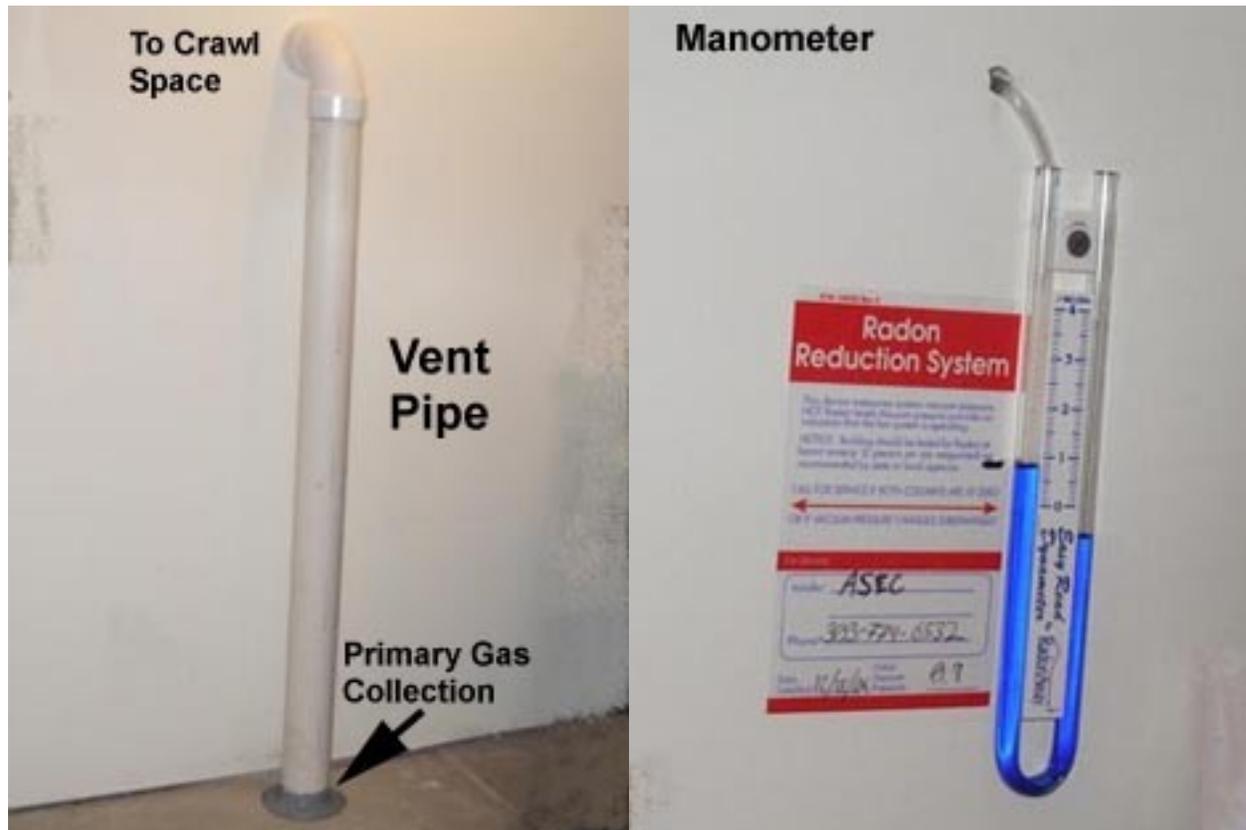
Basement Floor:

The primary gas collection is through the basement floor. They drilled a hole through the concrete, removed soil to create the required open space under the floor. They sealed in a vent pipe connected to the Radon ventilation system. In our house the vent pipe is routed through the crawl space and out through the garage, through the attic and out a roof vent. The ducting is 4.5 inch outside diameter PVC drain waste and vent pipe.

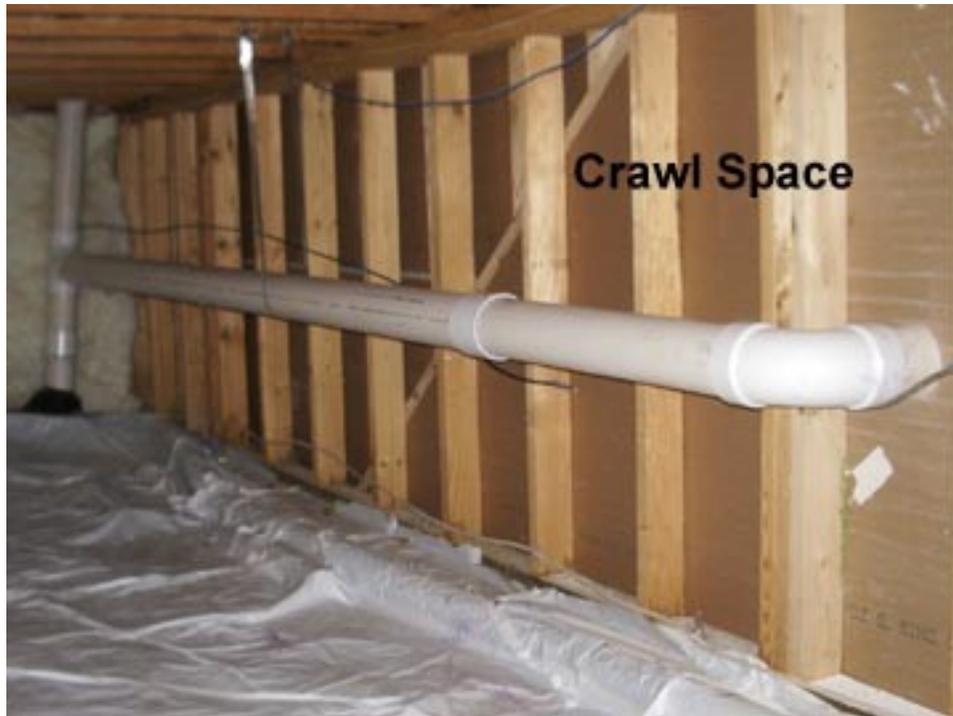
**Crawl Space what to expect:**

4-5 inch diameter corrugated and perforated flexible plastic ducting will be placed around the periphery and plumbed in to the Radon venting system.

A very tough plastic sealing membrane will be sealed to the concrete foundation with construction adhesive.

The manometer indicates if the system is maintaining the required vacuum under our house. Loss of this pressure differential would indicate pump failure or leakage in the sealing membrane and time to call the contractor.

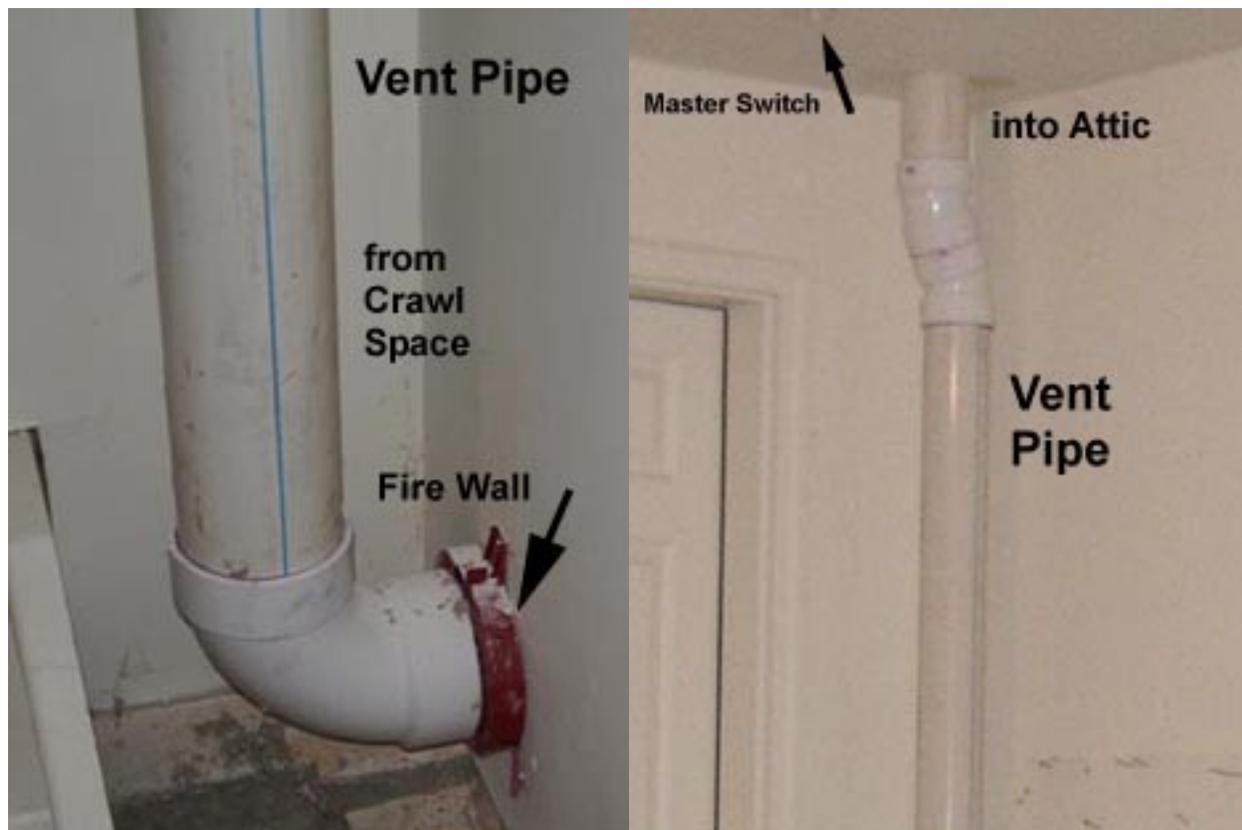
Exhaust Vent:

The collected gas is vented above the roof line to prevent its reentering the home. Some homes have it vented at the side of the house through an 'up spout'. In our case, we selected the option to have the ducting run through the garage, through the attic and out through a roof vent.

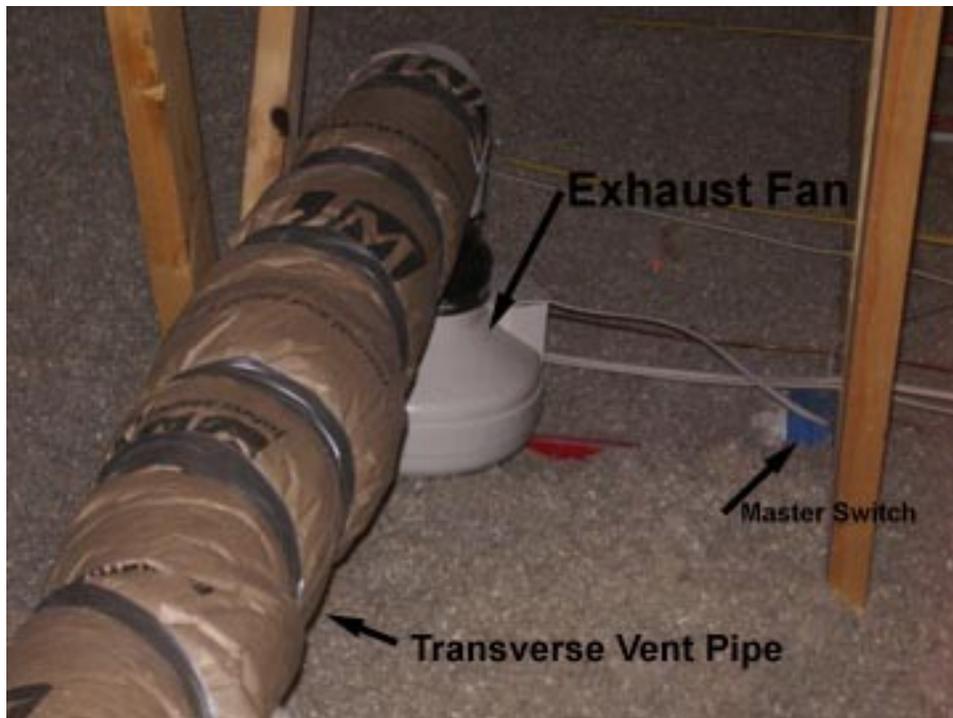
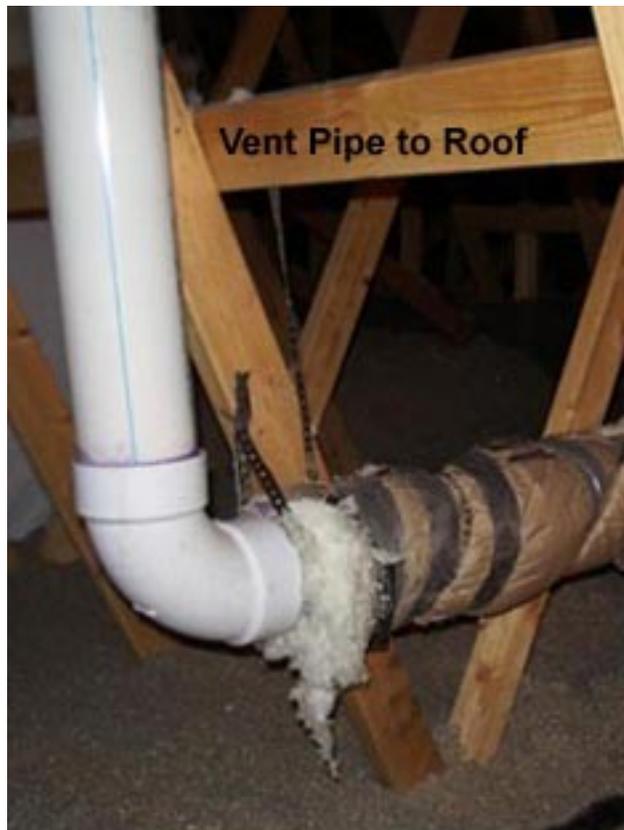
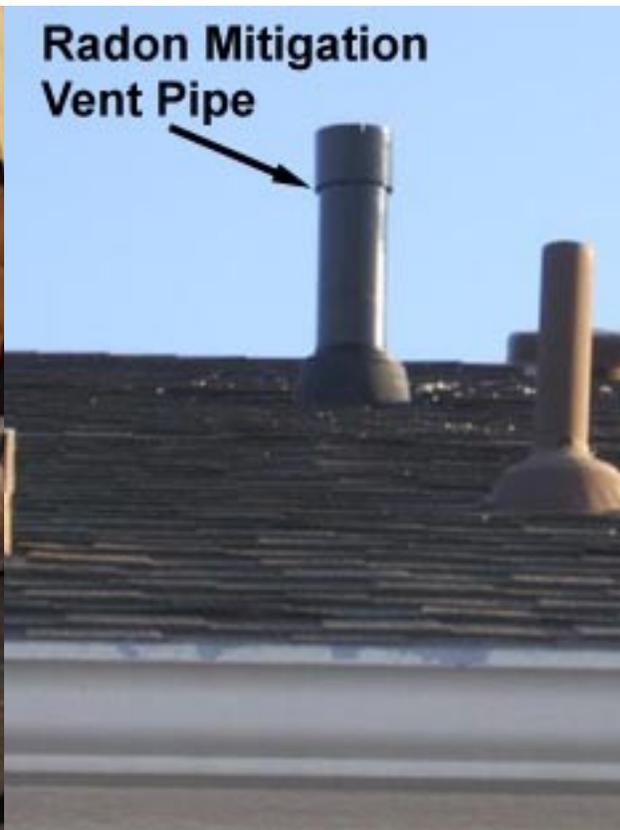
**Exhaust Fan:**

The Exhaust Fan is located in the attic. It is wired with a master switch mounted in the garage ceiling. Our fan is quieter and is a higher quality than many. It cannot be heard from any of the bedrooms nor the outside. A soft hum can sometimes be heard, however, from the Bedroom closet that has an attic trapdoor and also may be heard from the hallway. After a rainy period, the fan works harder to pump out the added moisture and is noisier for a while. When dryer weather returns, it quiets back down. I wonder if it is realistic to mount it to the attic trusses with vibration isolators so it could not be heard at all? I do not think anyone else has ever noticed any sound from our Radon mitigation system. The transverse duct in the attic is insulated to prevent any water vapor in it from freezing.
